# DACHS 1 LUBRICATING OIL PLANT PORTA, GERMANY

### (UNDERGROUND LUBRICATING OIL PLANT)

## PORTA (NEAR MINDSH), WESTPHALIA, GERMANY

> CIOS Target No. 30/217 Fuels and Lubricants

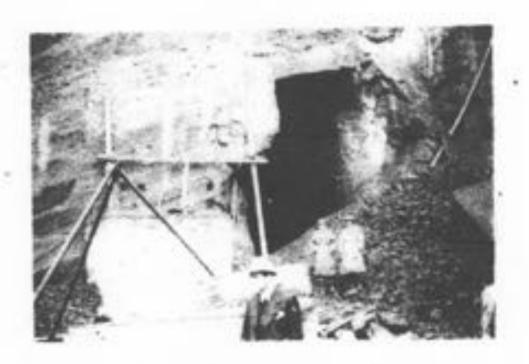
# Figure 1

Dachs 1. - Main Entrance

Center Foreground - Arnold H.W.A. Schröder

This is an underground plant for producing aviation lubricating oil from topped crude oil to be supplied from the Hanover area. It is located in an old sandstone quarry just back of the railroad station at Porta, near Minden, in Westphalia, Germany; Army map P. 3 (Detmold), Scale 1/100,000, coordinates 807052. The main entrance to the plant (es of 18 May 1945) is shown in Figure 1.

It was further planned to seal up the main opening (Fig. 1), through which the units had been brought, with approximately eight feet of concrete as bomb protection. In this same tunnel, the offices and control laboratories were to be built.

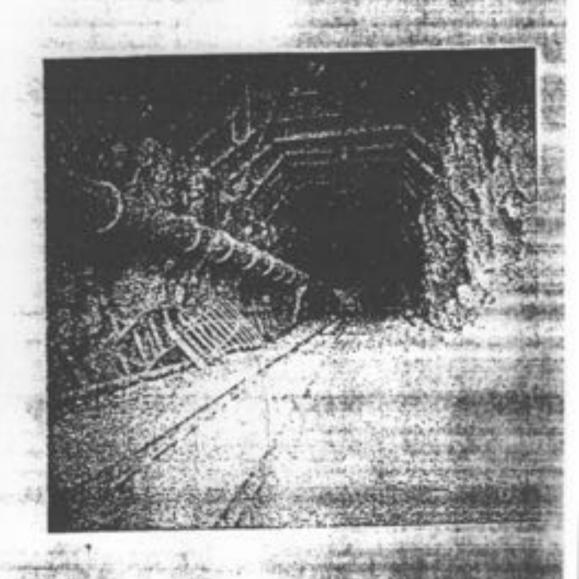
PHOTOGRAPH No.1. Temporary support for railway access tunnel to DACHS 1.

The factory is constructed from underground quarries in the Porta sandatone, but these were greatly enlarged to accommodate the plant. Railway access to the plant was intended (Photo. No. 1) but was not completed.

No falls of roof were seen in the factory area, but a heavy fall was seen in the railway turnel where this traverses the 18444. "Cronbrash". This tunnel was supported by steel ribs and timber laggings.

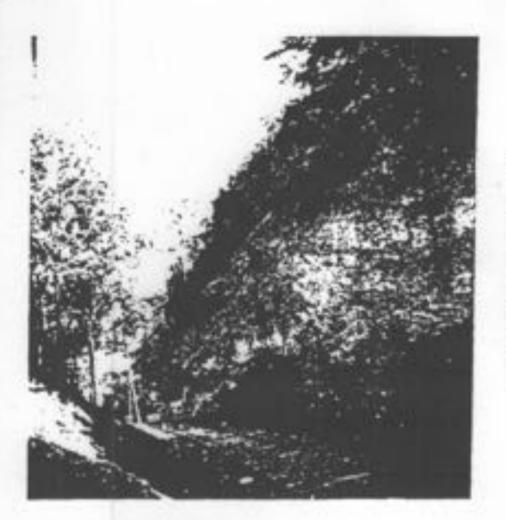
# PHOTOGRAPH No. 36.

Hornerworke,
Ports Westfelics.

Funicular reilway from
the entrance to
Hammerworke. Entrance
to Dechs I below,
River Weser in
distance.

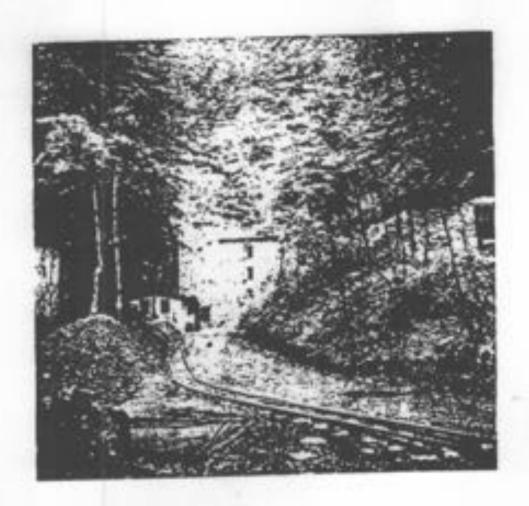
# PHOT CORLETT No. 20.

Denkn+1 Stollen, Berkhausen.

Entrence to fectory, showing blast well.

A blast wall of concrete 1.3 m. thick was constructed at the entrance to the quarry. (Photograph No. 20). There was a main entrance on the ground floor with openings at each storey for handl materials.

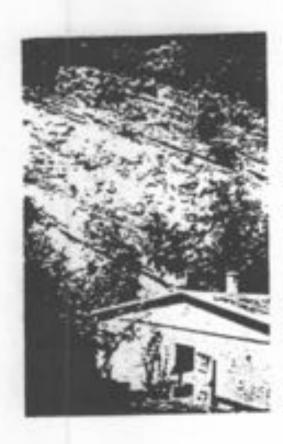
# PHOTOGRAPH No.21.

Denkmal Stollen, Borkheusen.

Outcrop of Porte sendstone showing dip.

The area is underlain by sedimentary rocks of jurassic age striking east and west and dipping to the north at about 20°. The outcrep of comparatively resistant sandstones is marked by a range of hills about 900 feet high running east and west for about 20 miles, through which the river Weser flows in a water gap known as the Ports sandstone. It is a massive moderately coarse grained

calcareous sandatone 40 metres thick, in the cutemop of which underground freestone quarries have been worked on both sides of the gap.
